Manhole Inspection Summary

Manhole # S29EE_002MH

Location Address: **1410 MORRIS ST**

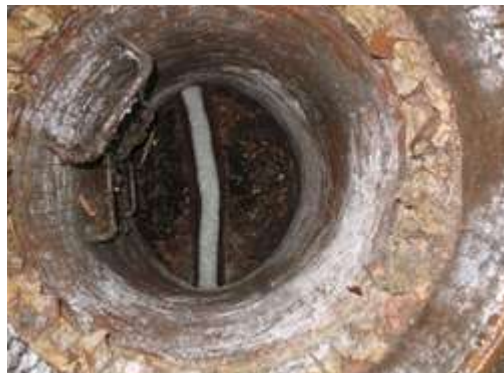
Top View

Frame offset. Adjustment deterioration, loose brick and infiltration. Evidence of surcharge - Bench debris

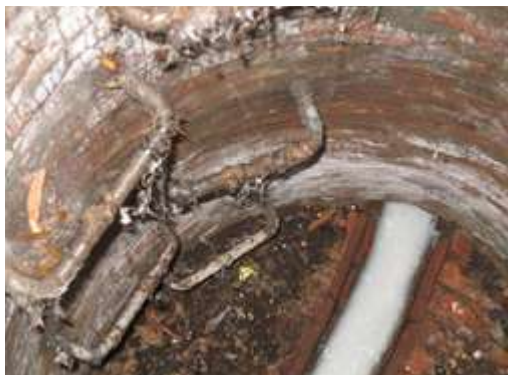
Defect

Barrel infiltration.

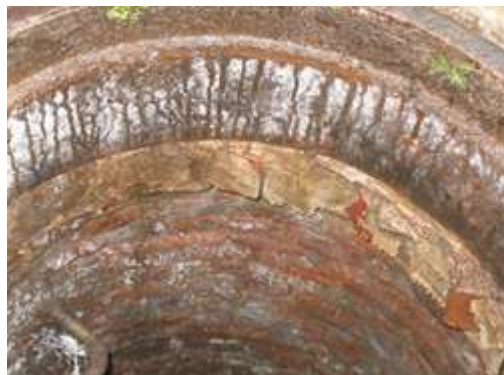
Defect

Adjustment infiltration.

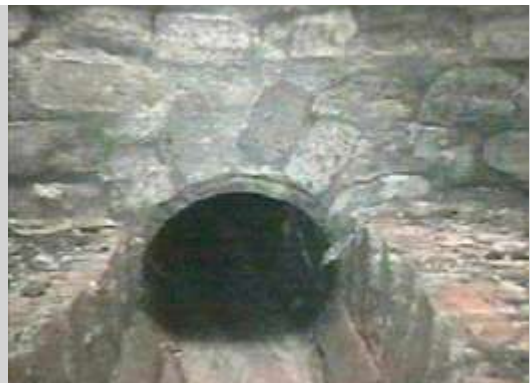
Pipe Out @ 12 O'Clock

Infiltration: **Evidence** Pipe Seal Cond: **Unknown**

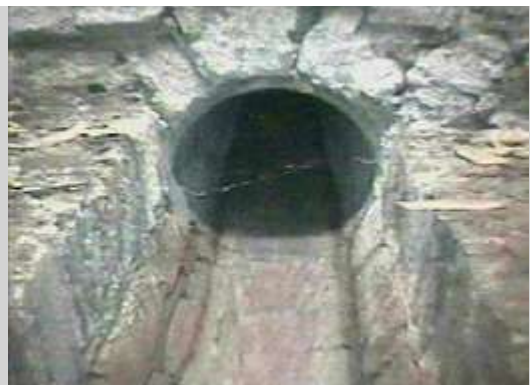
Pipe In @ 7 O'Clock

Barrel deterioration and infiltration.
